# Bearing damage and failure analysis

**SKF**®

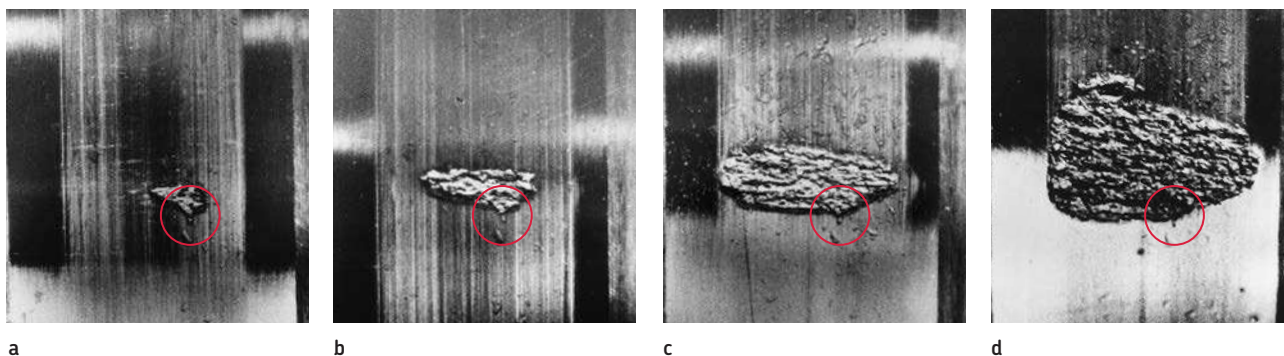
Fig. 1

A hard contaminant was over-rolled and made an indentation in the inner ring raceway of a cylindrical roller bearing (a). The surface initiated fatigue resulting in a spall started just behind the indentation. Over a period of time, spalling became more and more pronounced (b, c). If the machine was not stopped in time, secondary damage to machine components could have occurred. The initial indentation is no longer recognizable (d).

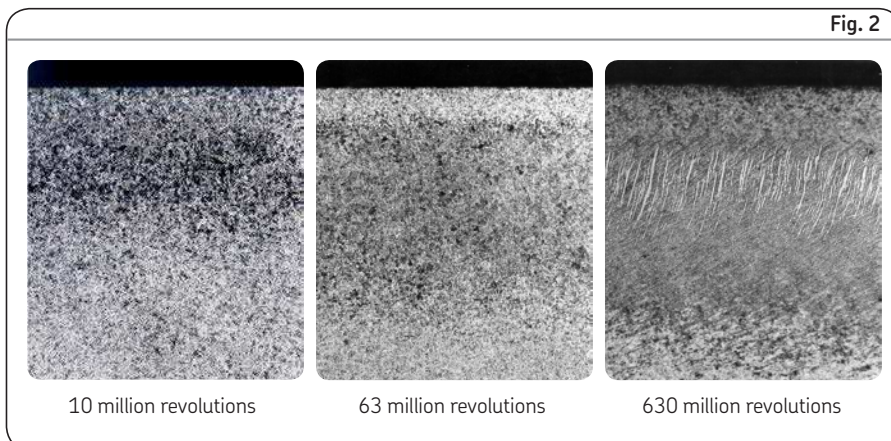
Changes in structure beneath the raceway surface over time (highly stressed, well lubricated small deep groove ball bearing)

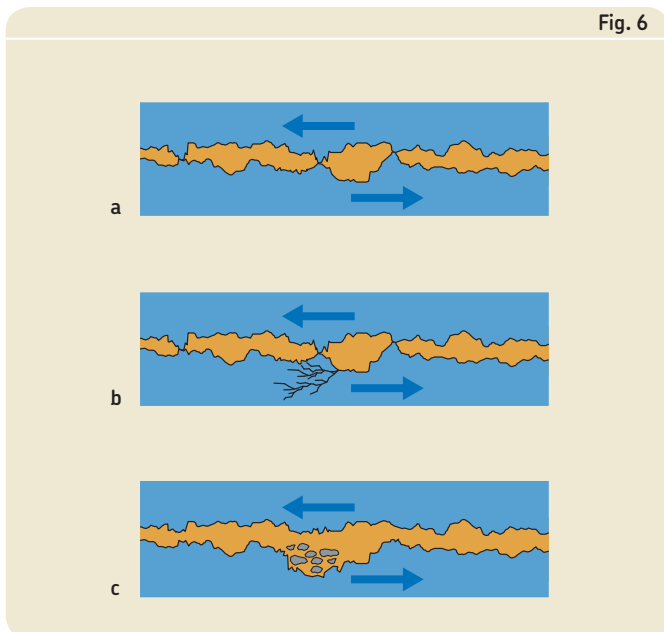
Mechanism of surface initiated fatigue

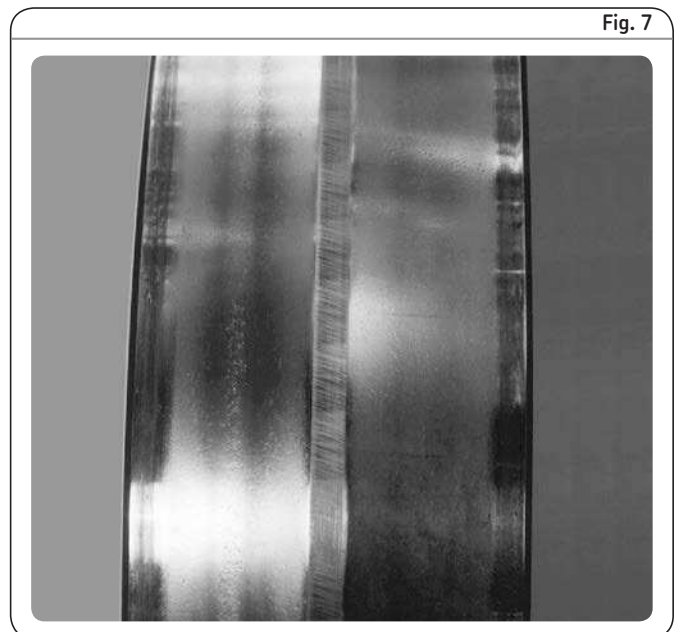
Microspalls on the inner ring raceways of a spherical roller bearing

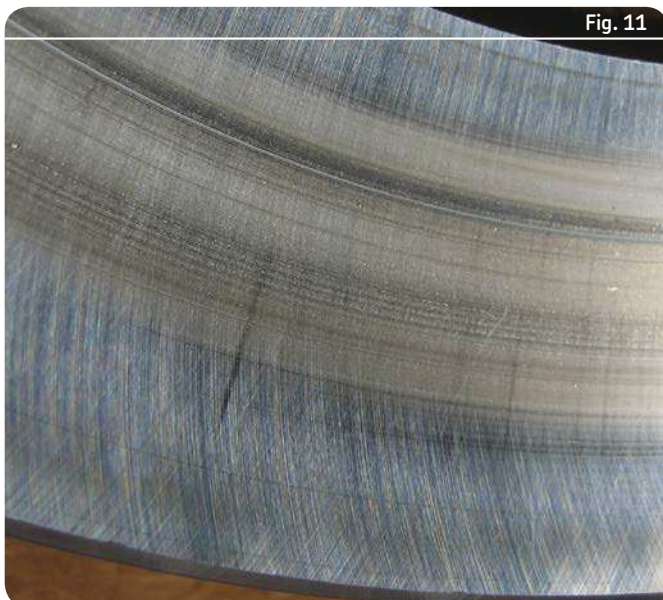
**Light abrasive wear on the outer ring of a spherical roller thrust bearing**

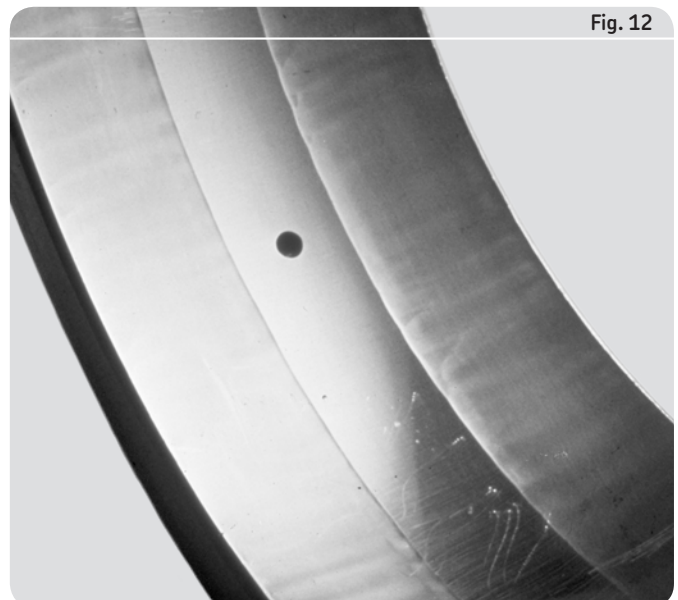
**Advanced abrasive wear on the outer ring of a spherical roller bearing (dull and matt raceways)**

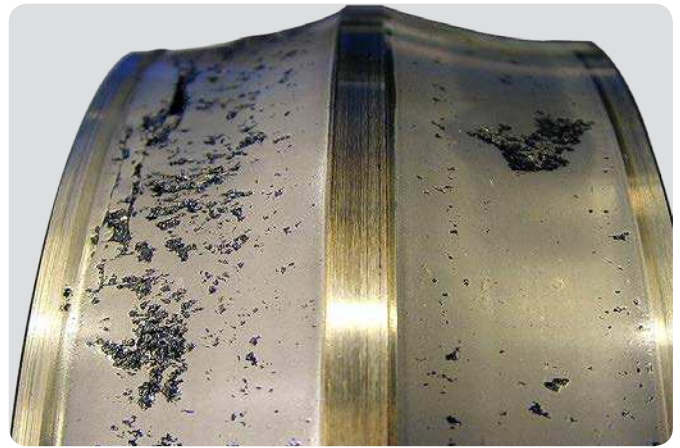
**Spherical roller bearing inner ring**  
*Inadequate lubricant film. Initially, abrasive wear due to contamination, developed into surface distress and spalling.*

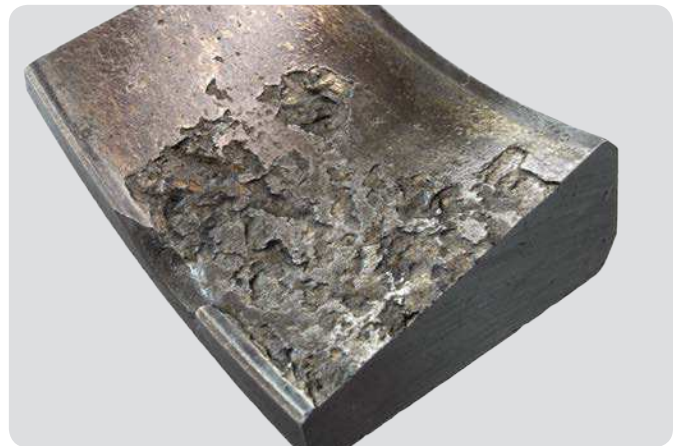
**Tapered roller bearing outer ring**  
*Inadequate lubricant film leading to surface distress and advanced spalling*

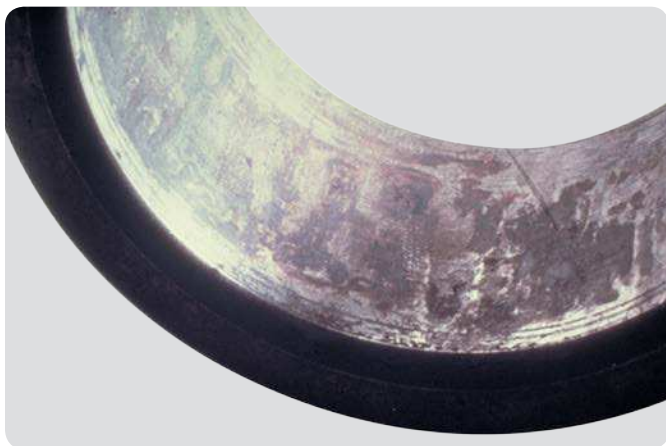
*Cylindrical roller bearing inner ring*  
Inappropriate shaft fit (too loose)

- Select appropriate fits
- Make sure the bearing seats are adequately machined
- Make sure the bearing seats conform to dimensional and geometrical specifications (even after overhaul of the machine)
- In the case of loose fits, consider applying an anti-fretting paste or coatings on one of the bearing surfaces

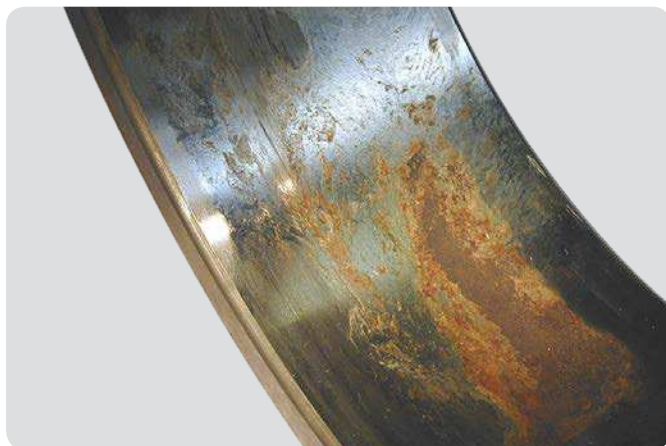
*Cylindrical roller bearing inner ring*  
Inappropriate shaft fit, uneven support

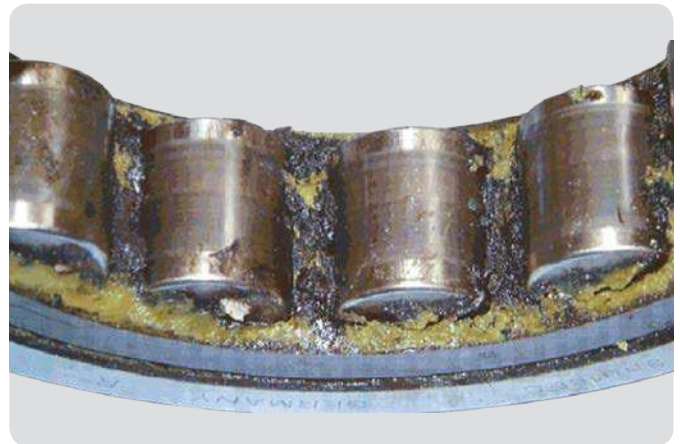
**Cylindrical roller bearing outer ring with cage, rollers and grease**  
Current leakage resulted in burnt grease (black) on the cage bars

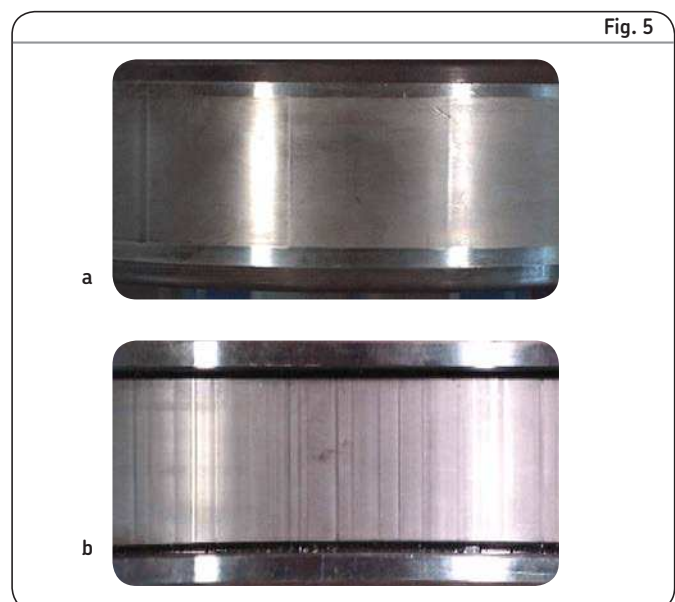
### Heavy wear and vibration marks on the inner ring (a) and outer ring (b) raceways of the cylindrical roller bearing

When the bearing was cut, and a section put under a microscope, some interesting conclusions could be made:

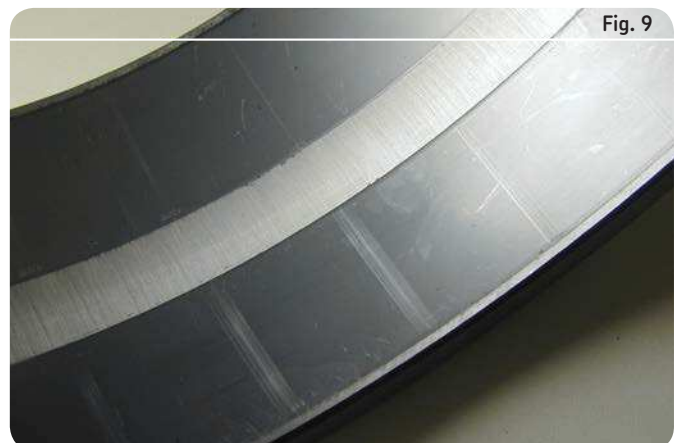
**Fig. 9**

**Outer ring: Heavy abrasive wear on the raceways and transverse smearing marks**
